**INVESTIGATION**

**COLLAPSE**

**HOTEL VENDOME**

**CITY OF BOSTON**

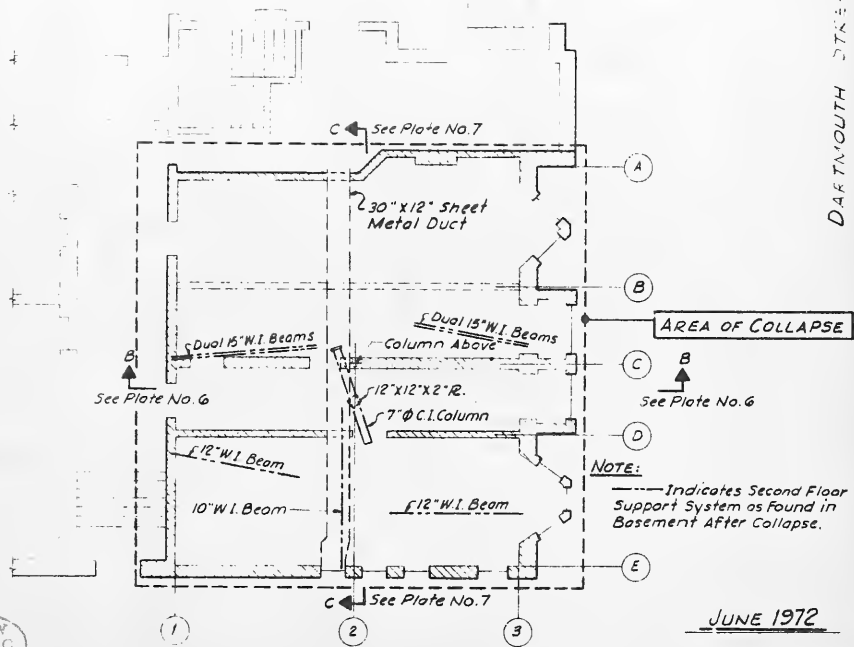
PLATE NO. 3

After the debris was carefully removed, a column (with an attached cap plate) and an isolated plate were found in the basement near the center of the area. (See Photos No. 15, 16 and 17). The column, though displaced, was intact, evidence that of itself it was not the cause of the failure. The isolated plate, later identified as being the base plate, was found alone on the basement floor. (See Plate No 3).

— Indicates Second Floor Support System as Found in Basement After Collapse.

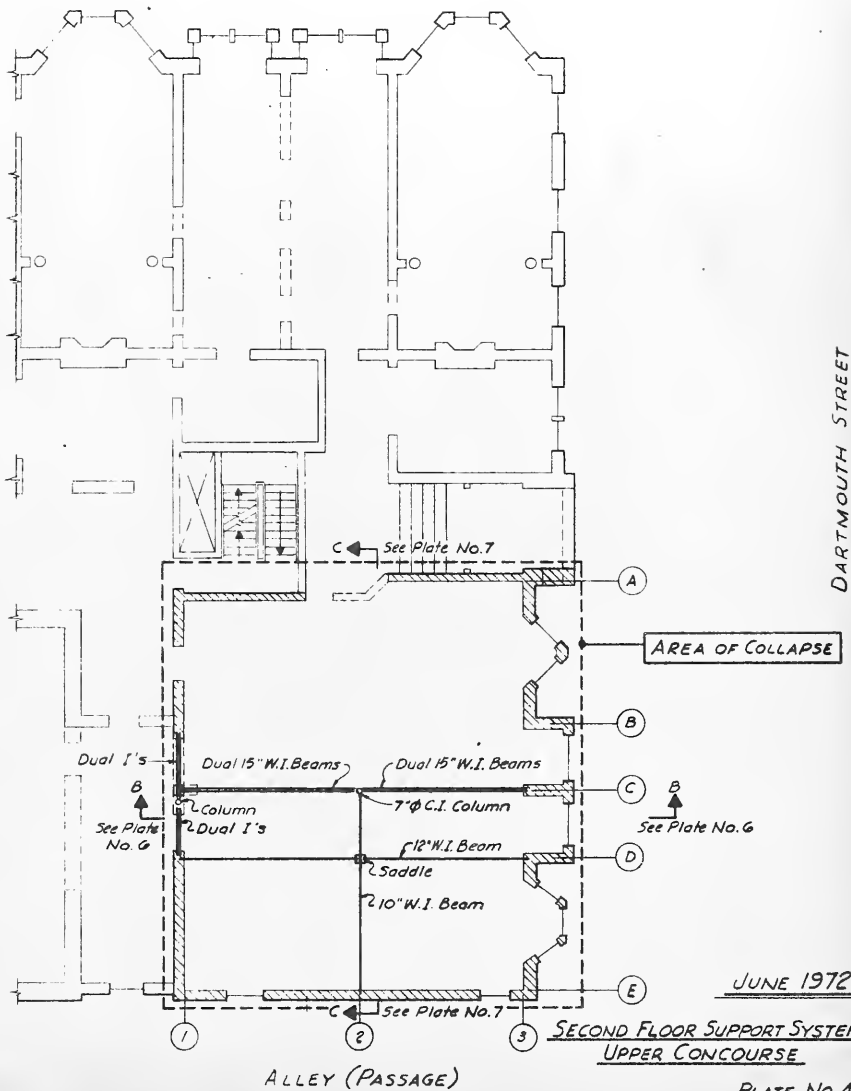
PLATE No. 4

Sometime around 1890 or before, alterations in the first story were made. The C-Line Wall and the partition on the D-Line were removed in this first story. Dual 15-inch wrought iron beams, together with a 7-inch diameter cast iron column at Line 2 were installed to carry the loads of the second floor and the floors above previously carried by the section of wall removed. The partition on the D-Line was replaced by 12-inch wrought beams suspended by a saddle on a 10-inch wrought iron beam spanning between the C-Line and the E-Line along Line 2. The 7-inch diameter column on Line 2 was based on a 12-inch by 12-inch by 2-inch plate directly over the lower portion of the wall at the C-Line.

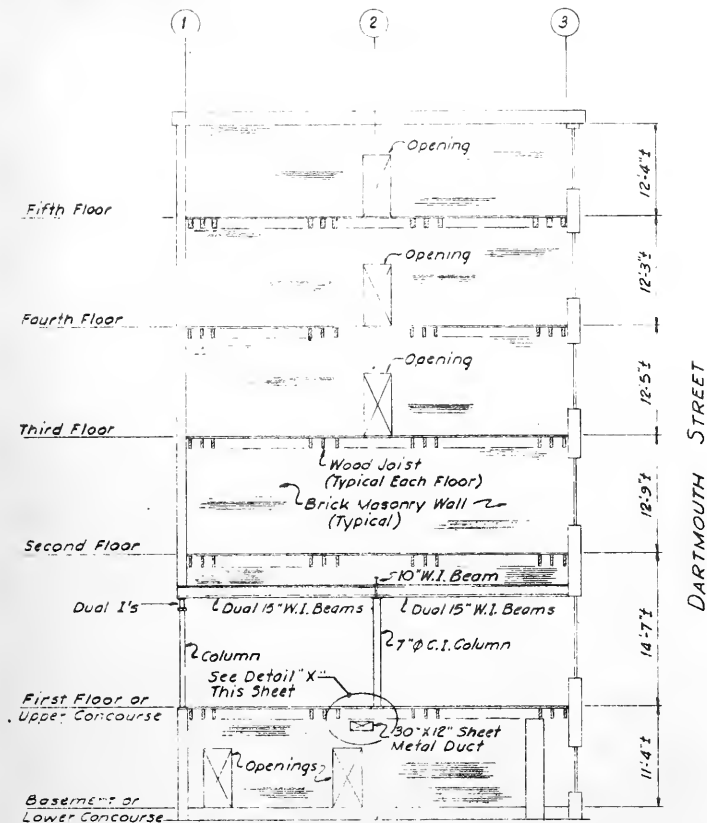
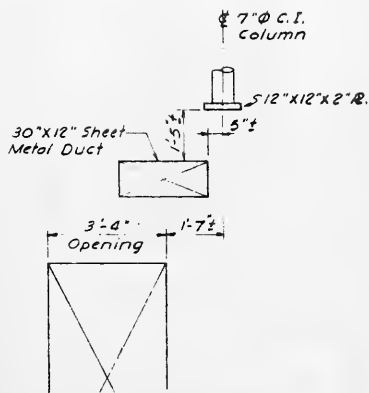
DETAIL "X"

The 30 inch by 12 inch metal duct passed through the C-Line Wall in the vicinity of an existing doorway. The top of this duct was approximately 17-inches below the underside of the column base plate. The side of this duct was within 5-inches of the centerline of this column.

The opening required for this duct was therefore in a very critical location in relation to the bearing area of the column and base plate.

When the computations were made, it was found that the load on the cast iron column from the dead <sup>LOAD</sup> alone, considering a small allowance for the corbelling action, was about 200,000 pounds. ( A study indicated that the corbelling or arching effect of the C-Line Wall was only of minor significance). The bearing stress on the wall due to this load was about 7 to 8 times the allowable stress for a masonry wall of a good grade brick with a good lime cement mortar.

When the opening for the air intake duct was made through the wall, the bearing stress at the side of the opening, already too high, was greatly intensified and was approaching a critical stage. It should be emphasized that in computing these stresses no live load was considered.

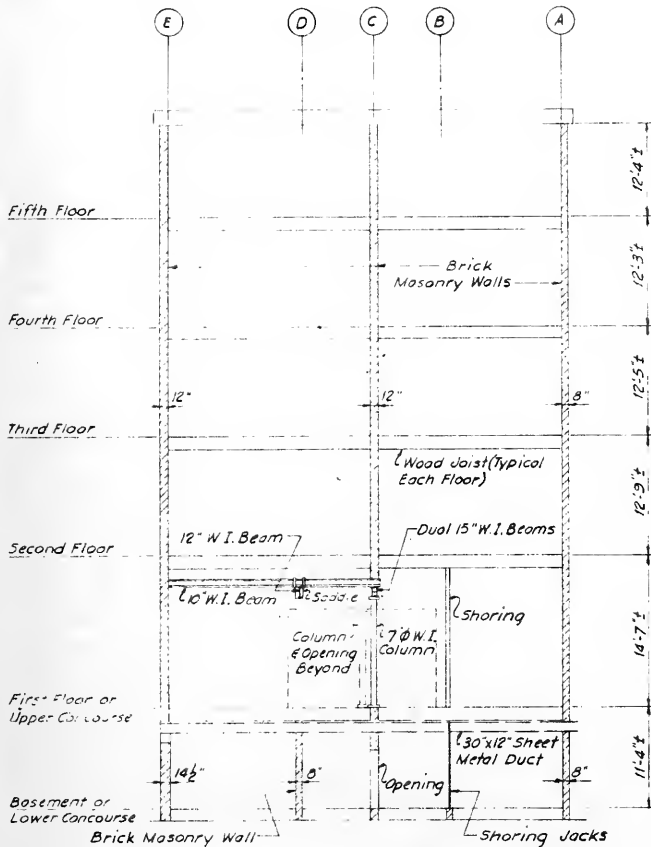
PLATE NO. 7

at hand. Sometime in the latter part of 1971, additional alterations to the wall on C-Line in the basement story were undertaken. These alterations consisted in part of an installation of a 30 inch by 12 inch sheet metal air intake duct.

In the first half of 1972, the E-Line Masonry Wall was also removed and shores placed.

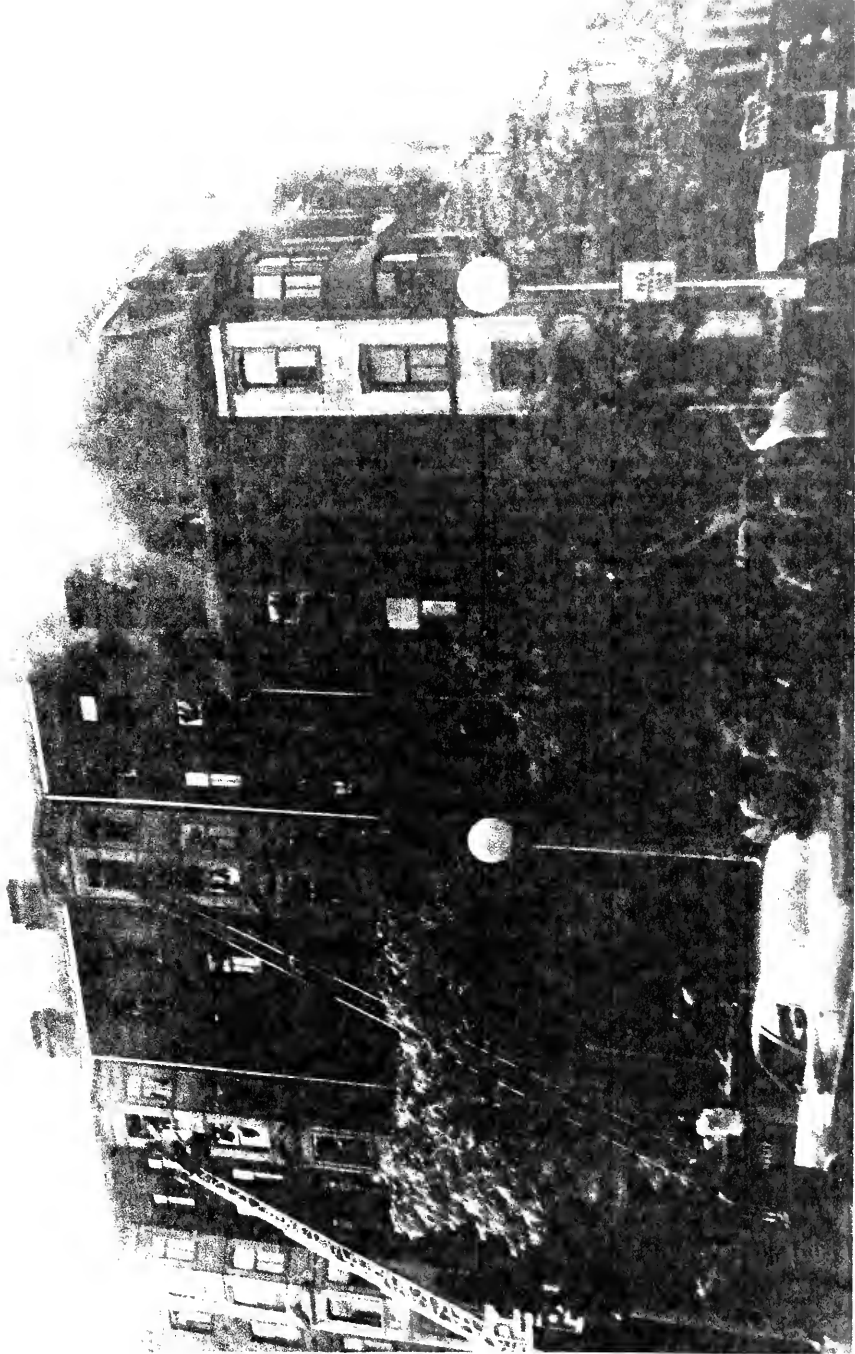
Photo A

In the late afternoon of Saturday, June 17, 1972, the Boston Fire Department suffered the worst disaster in its history when nine firefighters were carried to their deaths and several others were injured in the collapse of the southeast section of the old Hotel Vendome located at the corner of Commonwealth Avenue and Dartmouth Street, Boston. (See Photo A).

SOUTHEAST SECTION DURING FIRE

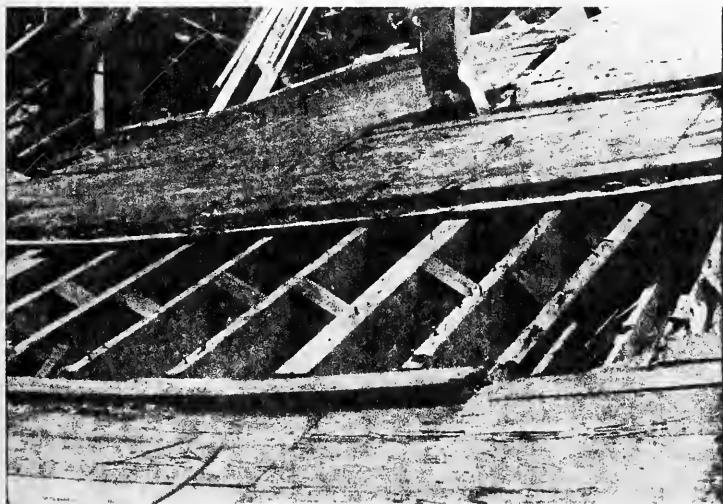
Photo No. 1

The floors in general were of hardwood applied on a layer of tongue and groove sheathing on a mortar of gypsum fill over a tongue and groove wood sub-floor. The supporting joists were of wood and were parallel to Dartmouth Street. It is thought that the fill was for the reduction of sound transmission between floors. A portion of the first floor surface appeared to be of some material other than wood. (See Photo No. 1).

FLOOR, TYPICAL  
SECTION

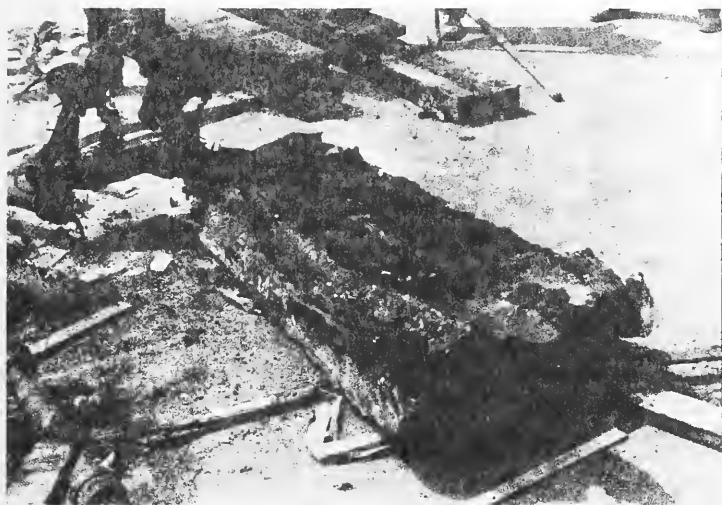
Photo No. 2

The roof construction appeared to be of tar and gravel on wood sheathing with wood joists supported on masonry walls. (Subsequently, a leveling fill of concrete was placed over the existing roofing and a wearing surface of quarry tile was installed).

ROOF, CONCRETE  
FILL AND  
SHEATHING

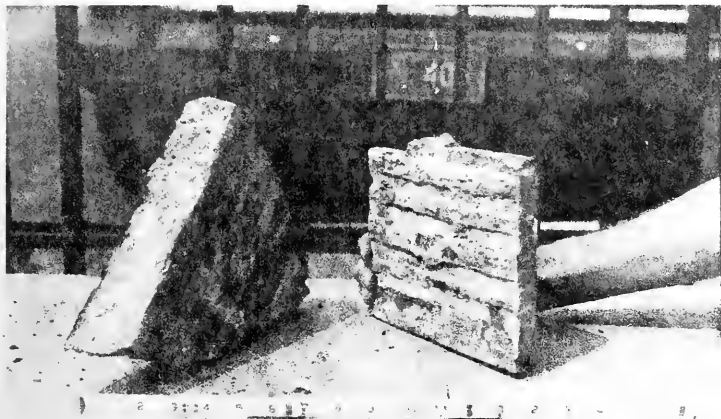
Photo No. 3

ROOF, CONCRETE  
FILL AND QUARRY  
TILE

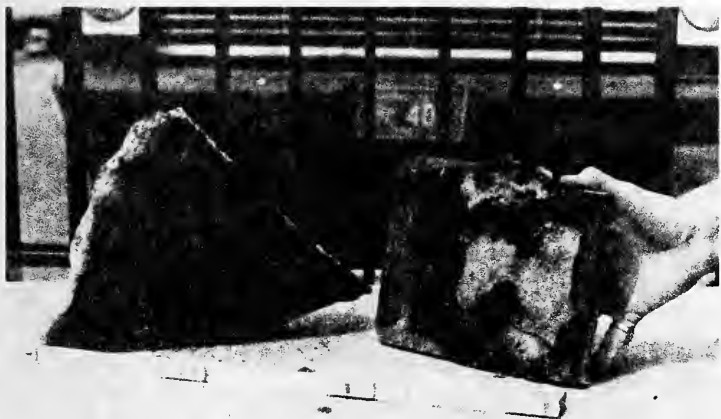
Photo No. 4

ROOF, CONCRETE  
FILL AND QUARRY  
TILE

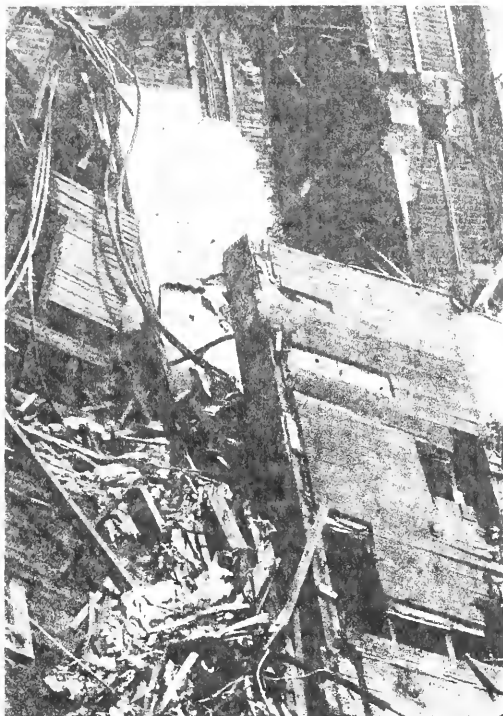
Photo No. 5

Large portions of the floors in the area between the A-Line and the C-Line were found stacked against the A-Line Wall. These portions were in an inclined position and were relatively undamaged. (See Photo Nos. 5, 6 and 6A). The portions of the floors between the C-Line and the E-Line were severely damaged. In general, the top surfaces of these floor sections were relatively undamaged with no evidence of sufficient debris to contribute to the collapse. Field measurements provided substantial verification of the original construction.

FLOOR PORTIONS AGAINST A-  
LINE, BETWEEN A-LINE AND  
C-LINE

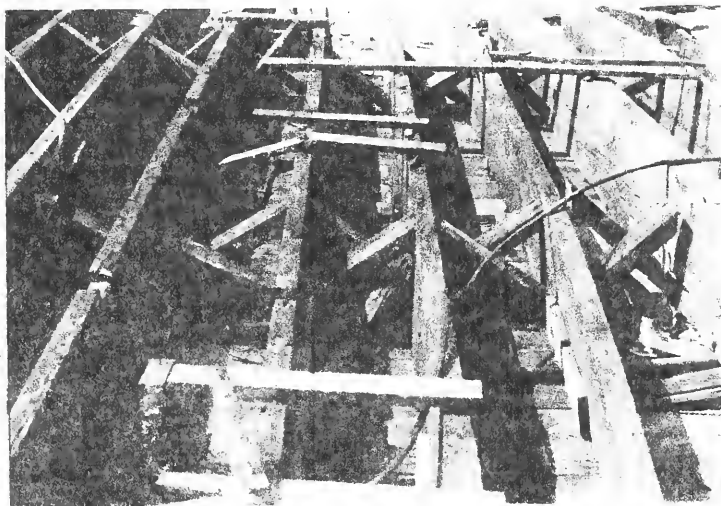
Photo No. 6

RELATIVELY  
UNDAMAGED FLOOR  
PORTIONS AFTER  
REMOVAL

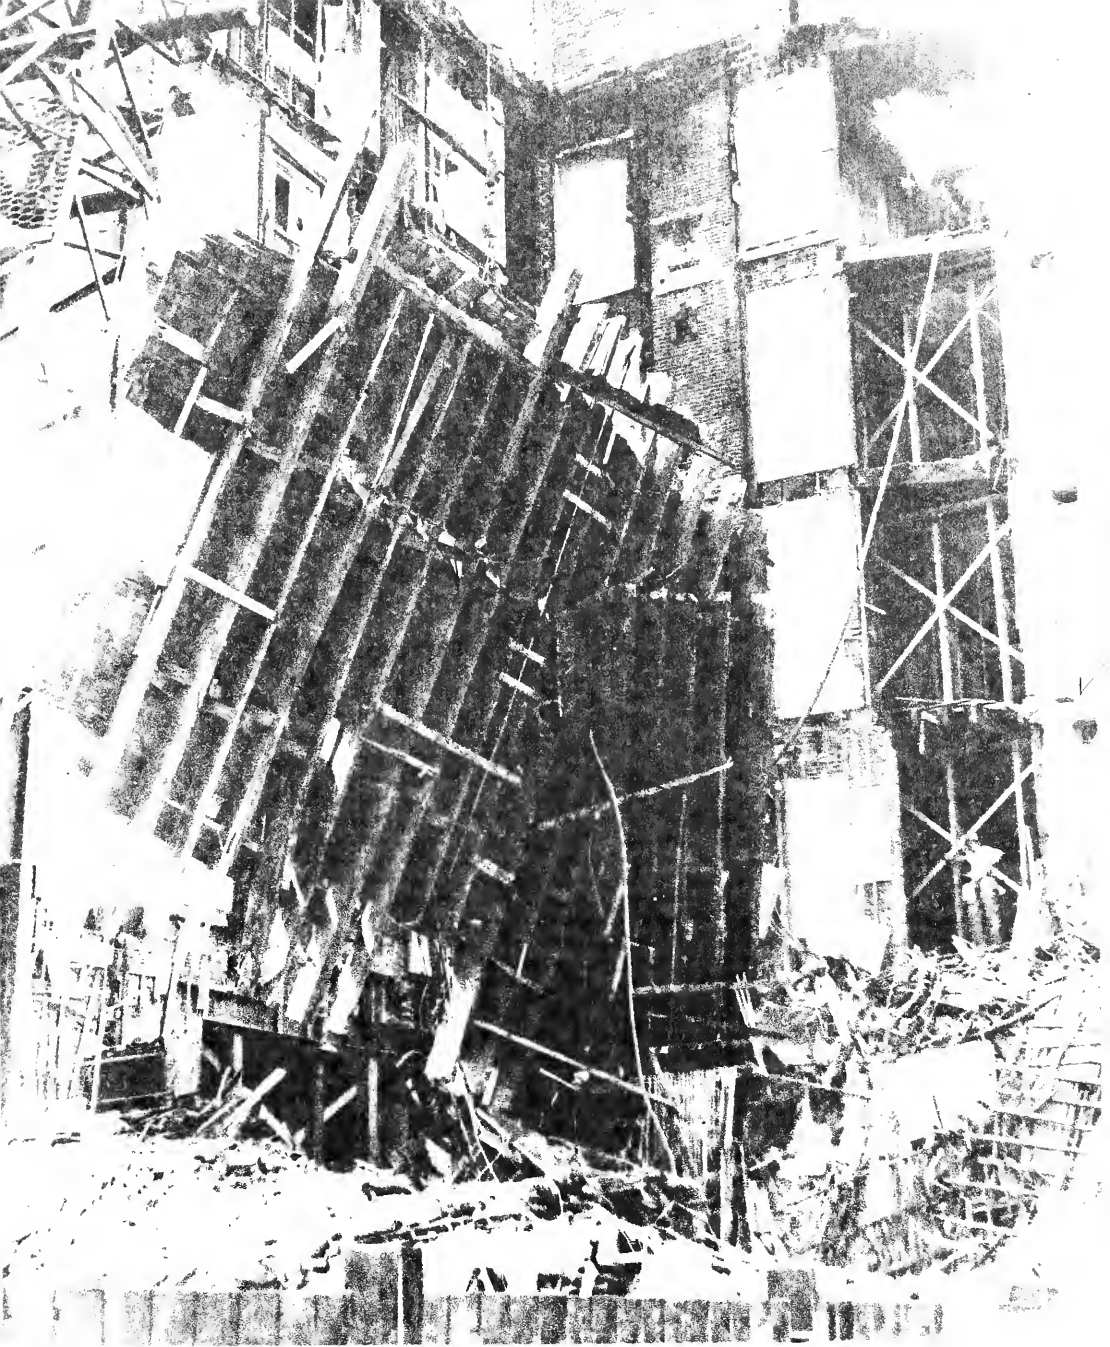
Photo No. 6A

FLOOR SECTIONS BEING REMOVED

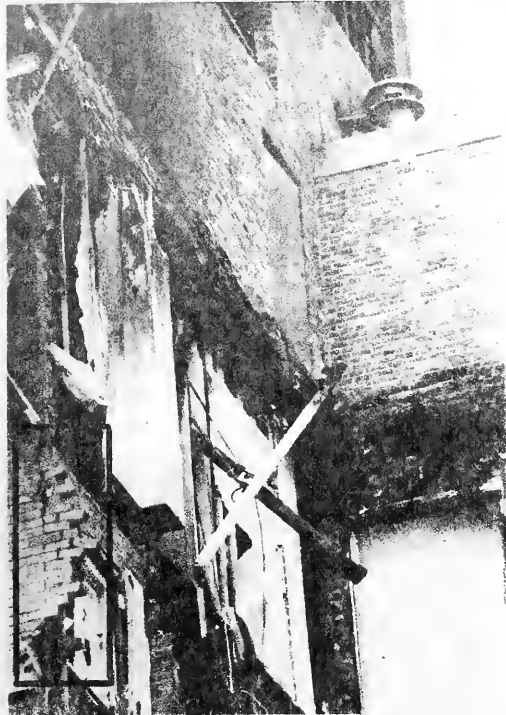
Photo No. 7

Several bricks at the broken end of the upper portion of the E-Line Wall above the third floor were tilted downward. (See Photo No. 7). While others at the broken end of the lower portion of the same wall were twisted outward. (See Photo No. 8). Large portions of the

E-LINE WALL AT FOURTH STORY

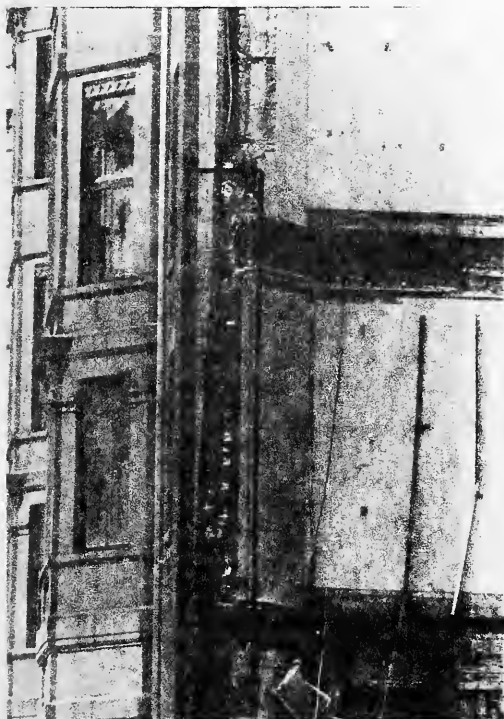
Photo No. 8

E-LINE WALL AT THIRD STORY

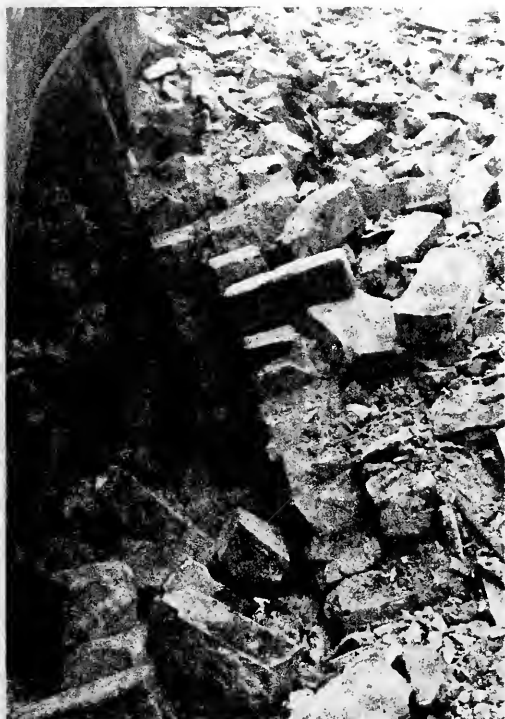
Photo No. 9

collapsed wall originally near ground level were found relatively intact lying against Ladder Truck 15 which was positioned in the alley about three feet from the original wall. (See Photo Nos. 9 and 9A).

LOWER PORTIONS OF E-LINE WALL  
LAYING AGAINST LADDER TRUCK 15

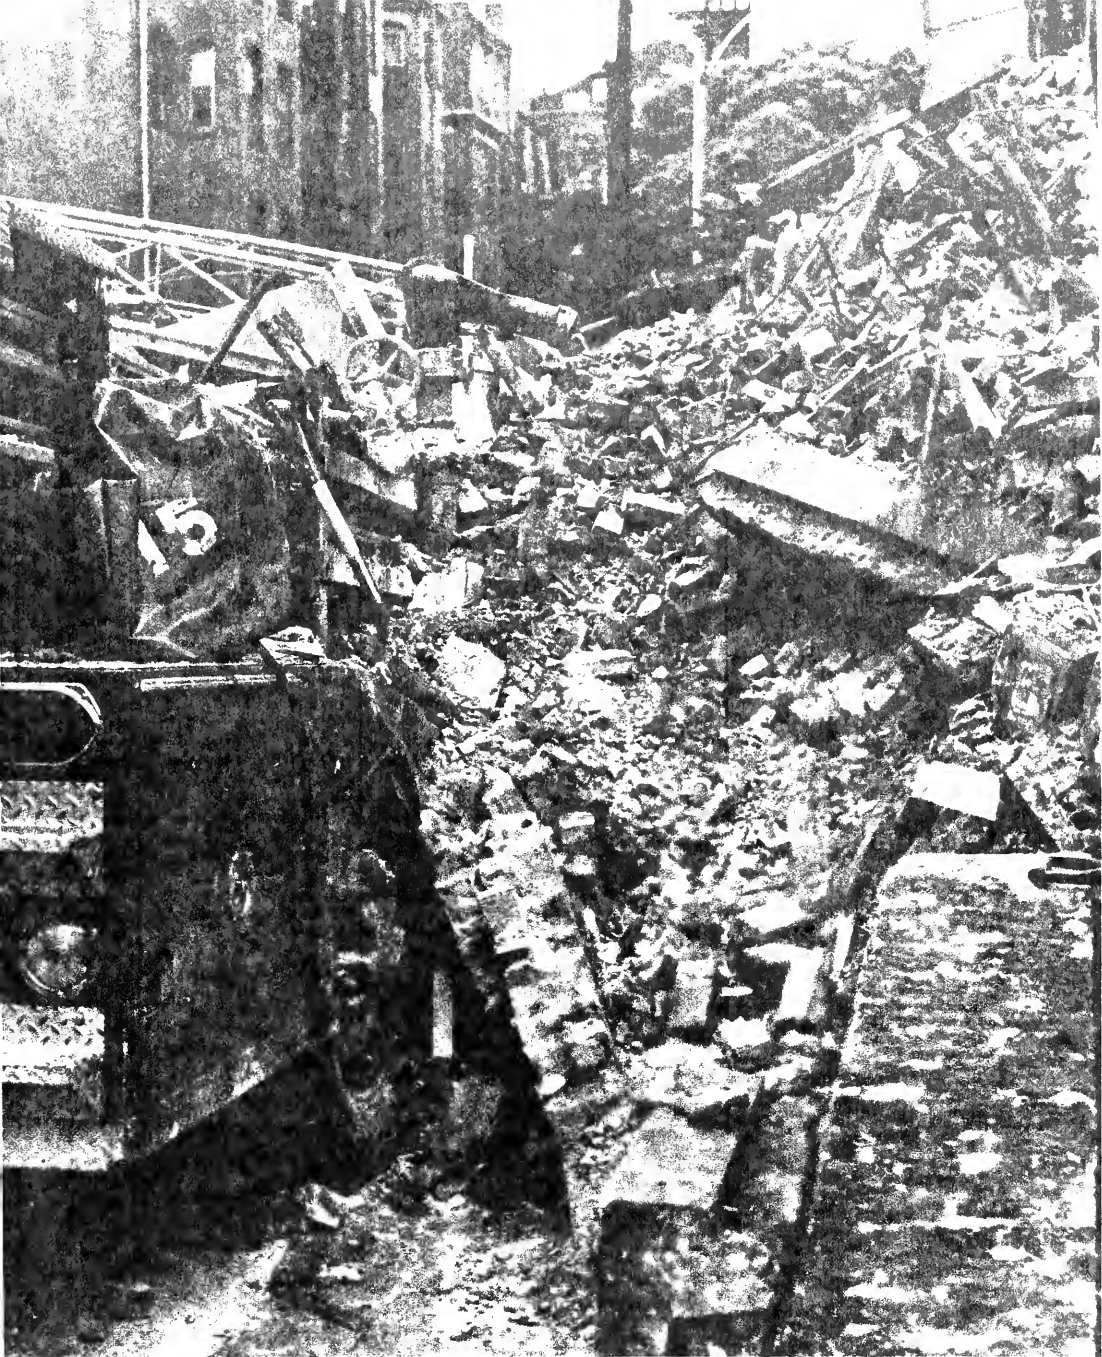
Photo No. 9A

LOWER PORTIONS OF E-LINE WALL LYING  
AGAINST LADDER TRUCK 15

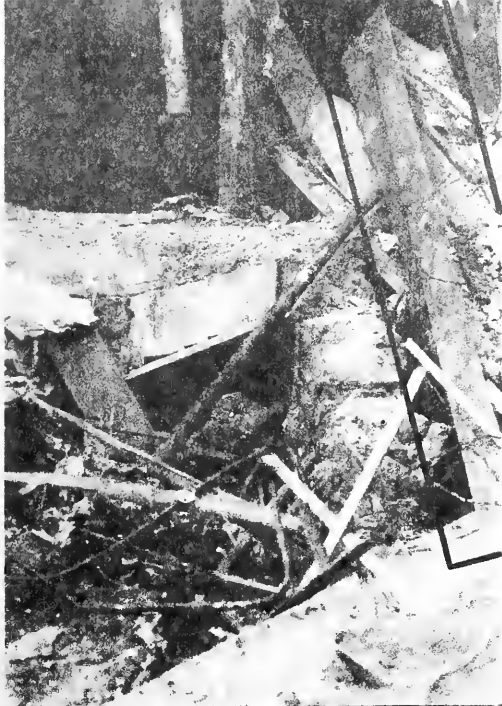
Photo No. 10

Several metal beams were uncovered below the second story. (See Photos No. 10, 11, 12, 13 and 14).

DUAL BEAMS LAYING ADJACENT TO  
C-LINE WALL BETWEEN LINES 1  
AND 2

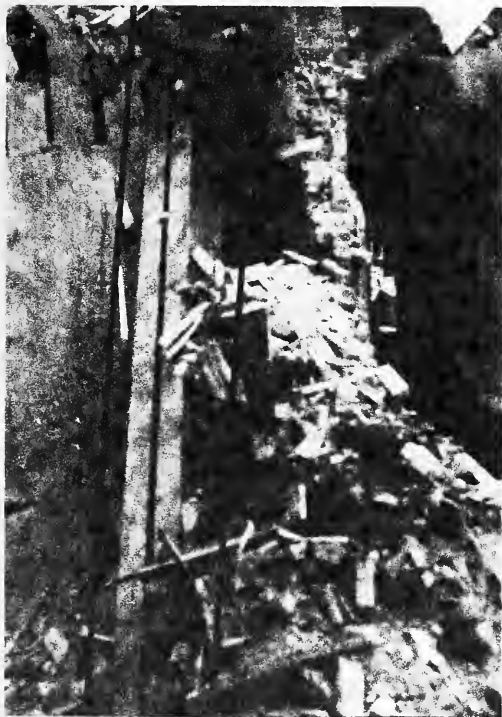
Photo No. 11

DUAL BEAMS LAYING ADJACENT TO  
C-LINE WALL BETWEEN LINES 2  
AND 3

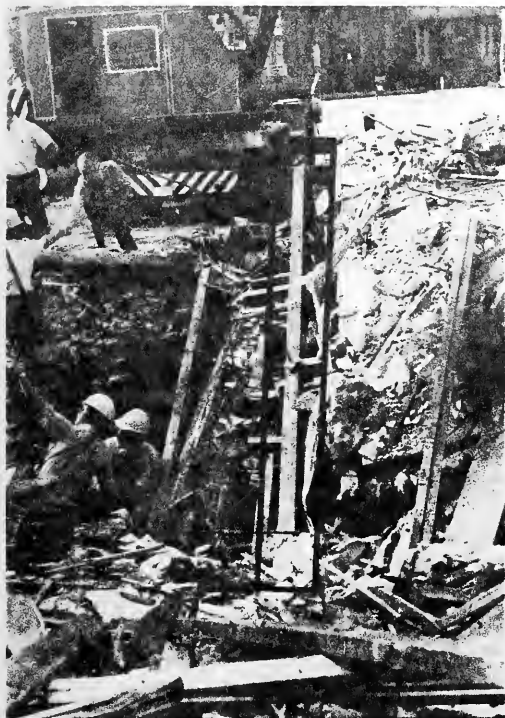
Photo No. 12

SINGLE BEAM LAYING ADJACENT  
TO LINE 2 BETWEEN C-LINE AND  
E-LINE

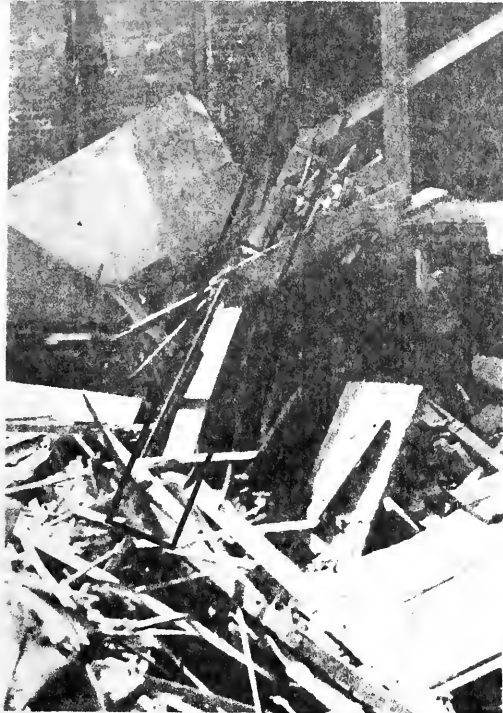
Photo No. 13

SINGLE BEAM LAYING BETWEEN  
LINES 1 and 2

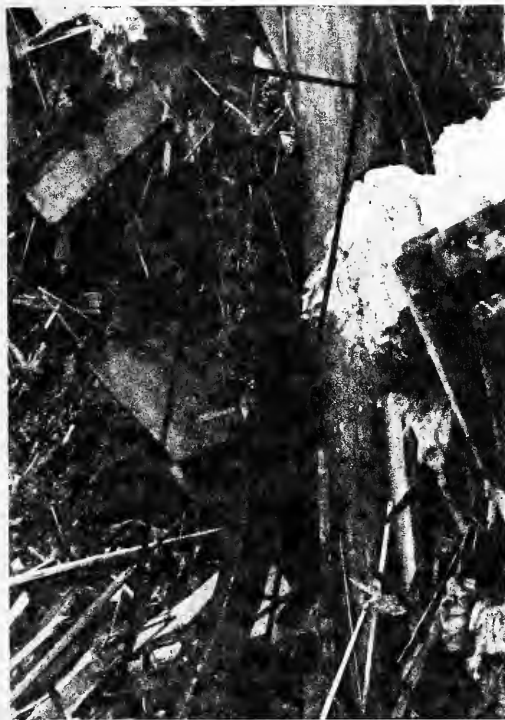
Photo No. 14

SINGLE BEAM LAYING BETWEEN  
LINES 2 AND 3

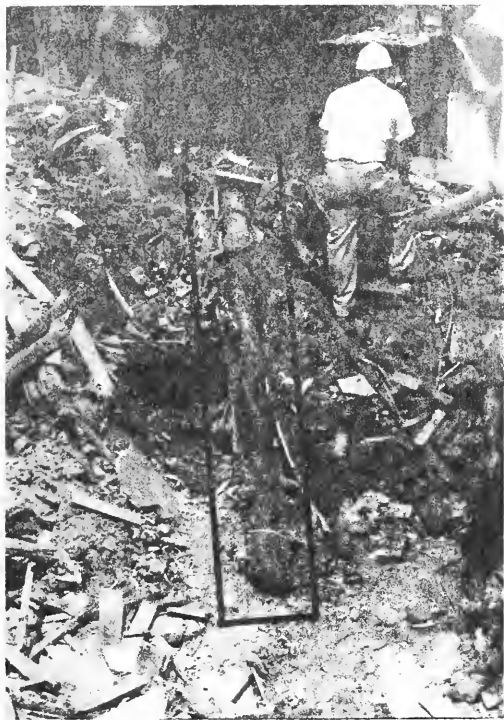
Photo No. 15

COLUMN LAYING NEAR LINE 2  
BETWEEN C-LINE AND D-LINE.  
BOTTOM PORTION AT BASEMENT  
FLOOR

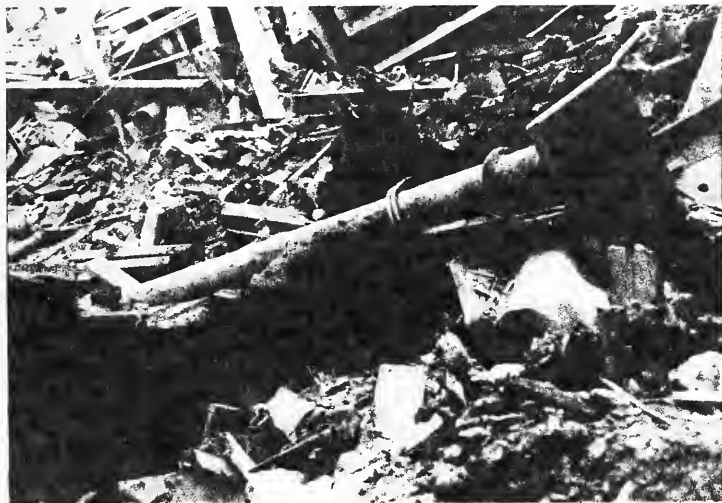
Photo No. 16

TOP PORTION OF  
COLUMN LAYING  
ACROSS C-LINE  
WALL

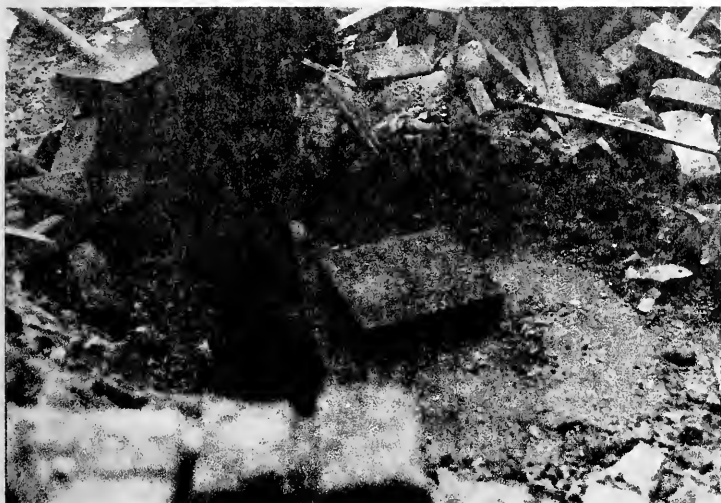
Photo No. 17

COLUMN BASE PLATE  
LAYING ON  
BASEMENT FLOOR

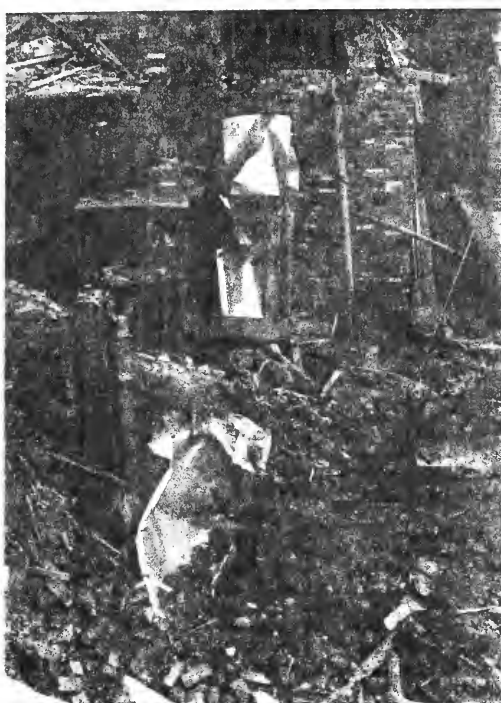
Photo No. 18

A section of sheet metal duct approximately 30 inches by 12 inches was found passing through the A-Line Wall near Line 2. Another flared portion of metal duct was found at a window opening in the E-Line Wall at ground level near Line 2.

SHEET METAL DUCT AT A-LINE  
WALL

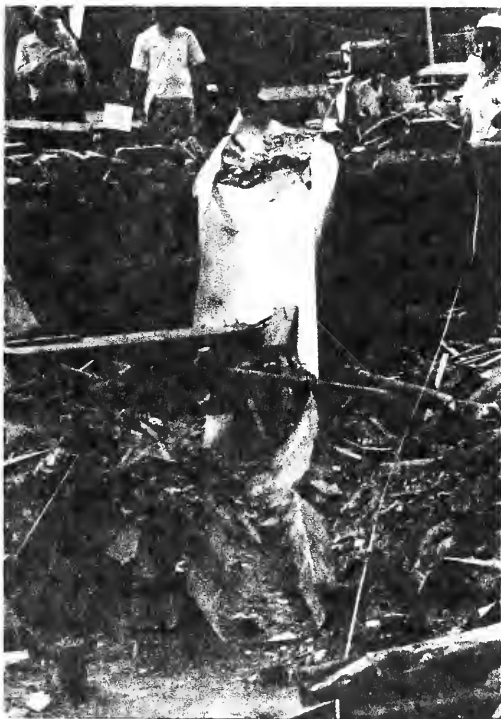
Photo No. 19

SHEET METAL DUCT AT E-LINE  
WALL

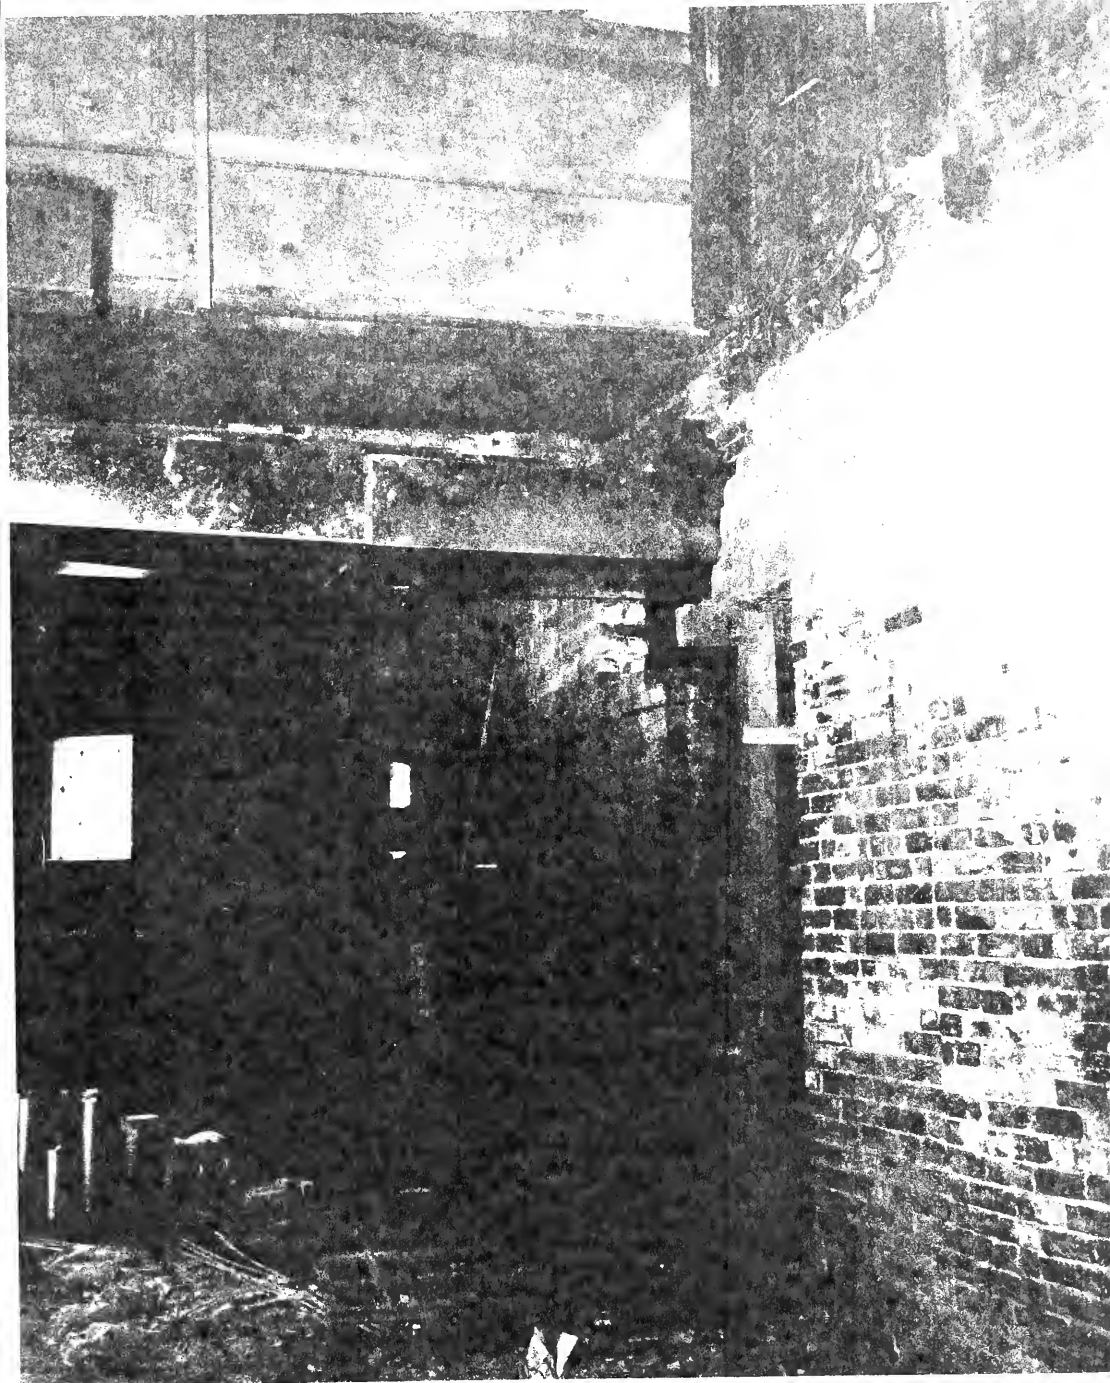
Photo No. 19A

SHEET METAL DUCT PASSING THROUGH B-LINE WALL  
(PHOTO TAKEN SOMETIME BEFORE COLLAPSE)

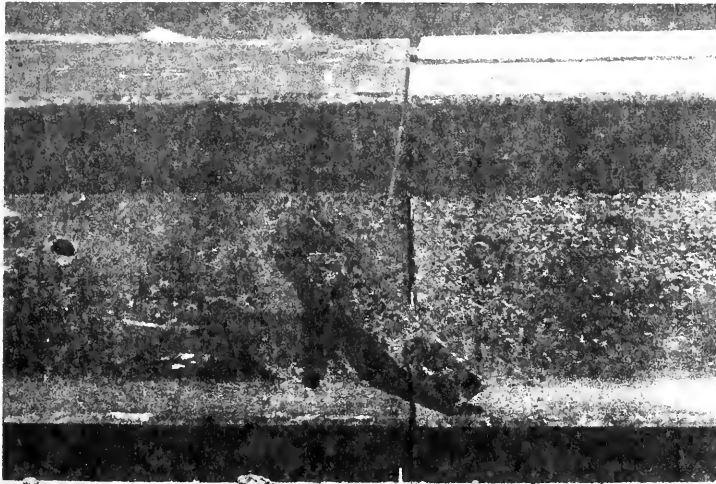
Photo No. 21

INTERIOR ENDS OF  
DUAL 15-INCH BEAMS  
(AT LINE 2 AND C-  
LINE)

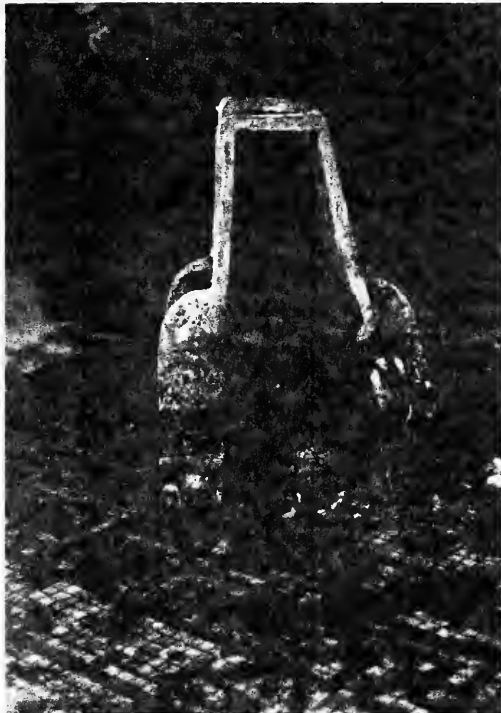
Photo No. 22

SADDLE USED TO SUPPORT 12-INCH  
BEAMS FROM 10-INCH BEAM (AT  
LINE 2 AND D-LINE)

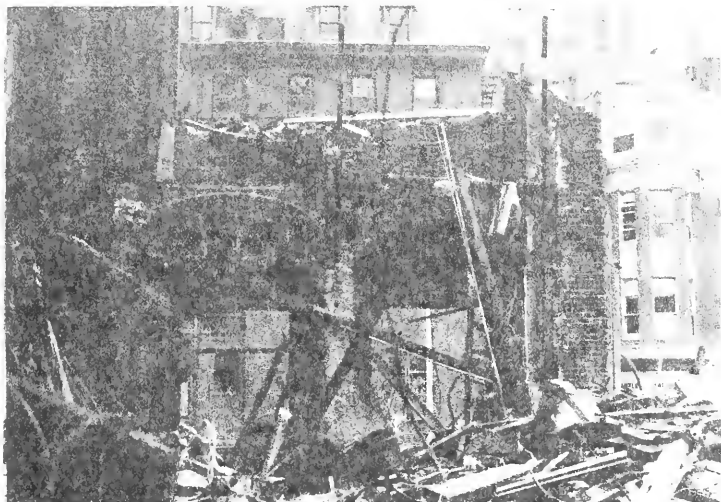
Photo No. 23

WALL POCKETS IN  
LINE 3 WALL FOR  
C-LINE AND D-  
LINE BEAMS

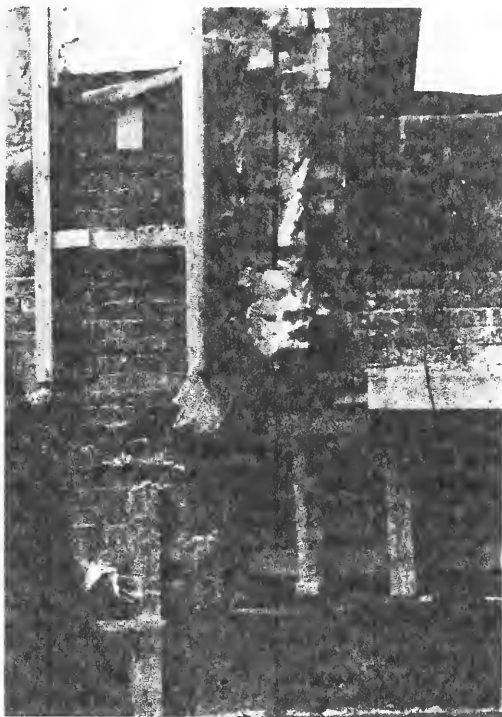
Photo No. 24

SUPPORT AT LINE 1 WALL FOR  
C-LINE BEAMS

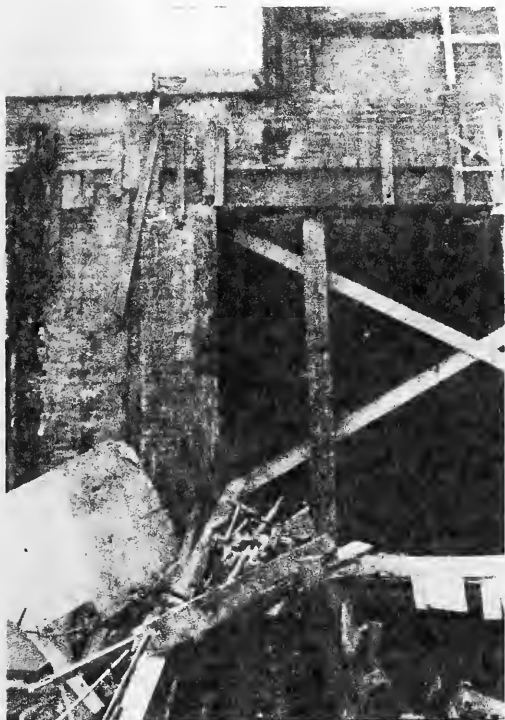
Photo No. 25

SUPPORT AT LINE 1 WALL FOR  
D-LINE BEAM

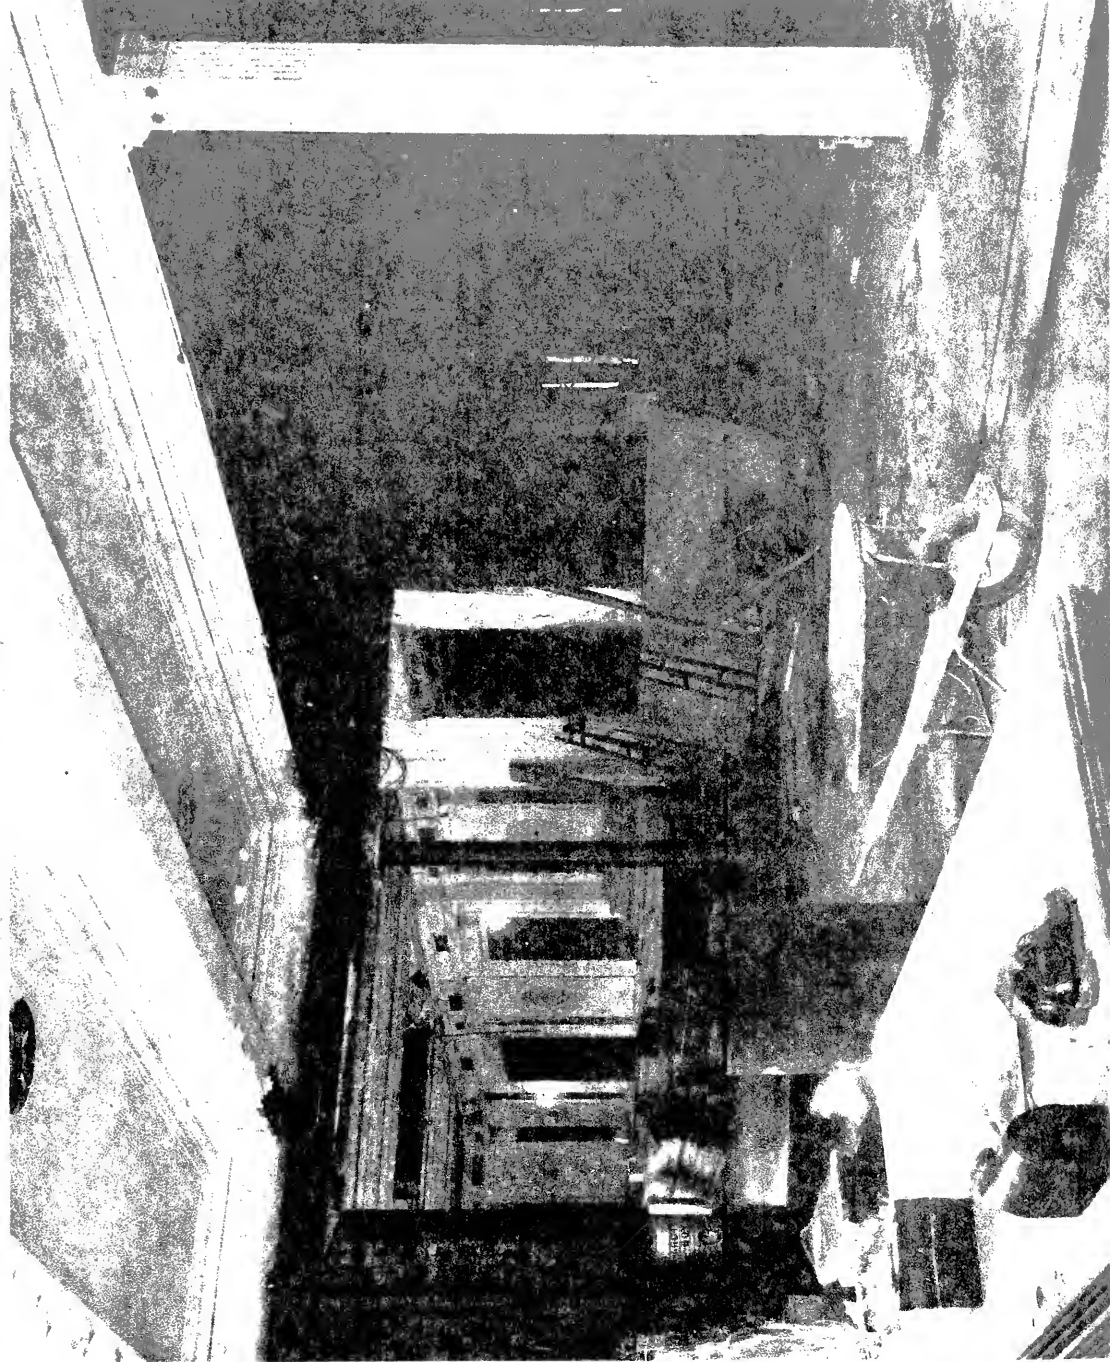
Photo No. 25A

10-inch wrought iron beam, had two single 12-inch wrought iron beams suspended from it, all of which formed a part of the second floor framing system. Thus, the 7-inch cast iron column was the main support of the bearing wall above the second floor with the addition of at least half of the second floor load in the area. The base plate of this column was positioned on the wall along the C-Line approximately at the first floor level.

COLUMN AND PORTIONS OF C-LINE AND D-LINE BEAMS  
(PHOTO TAKEN SOMETIME BEFORE COLLAPSE)
